## CASE STUDY 1 - SIMPLE VERTICAL CRACK

## CASE STUDY 2 - HOUSE ON SHRINKABLE CLAYS

## CASE STUDY 3 – MOVING CASTLE

## CASE STUDY 4 – INSURANCE CLAIM AFTER PARTY WALL WORKS

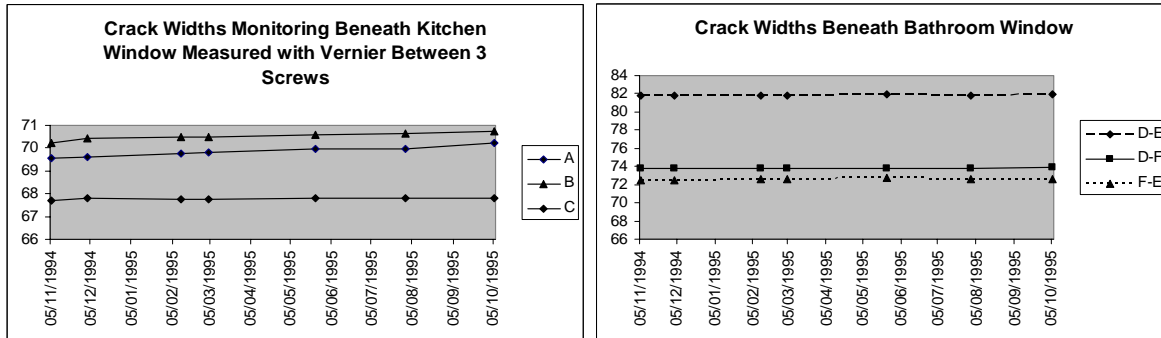
This illustrates a relatively straightforward situation where there was an almost vertical crack through the corner of a window. It was thought that movement might be associated with a Viking defensive ditch that passed somewhere through the house. Three pins were set up on the crack at two locations. As indicated below, results were not clear as the crack was opening horizontally without any significant vertical shear movement.

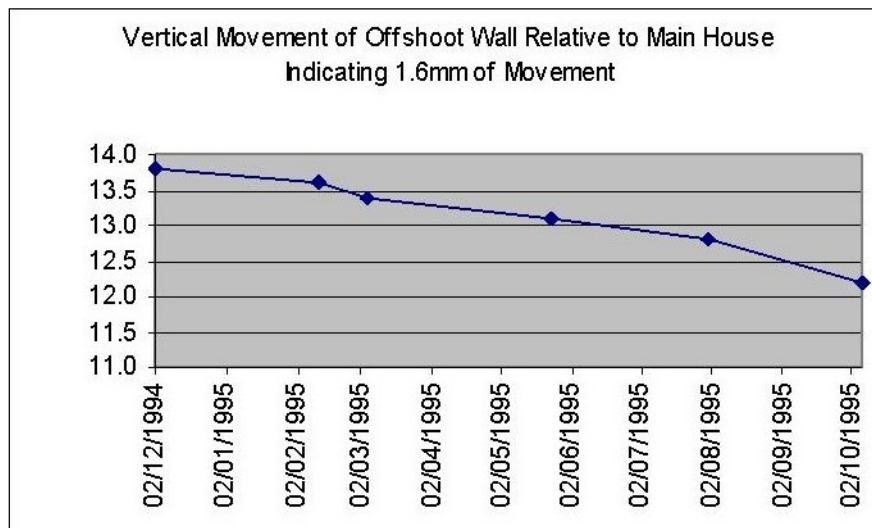
Movement Gauges were subsequently installed on the wings either side of the crack. A third gauge was located on a third wall.

The Movement Gauges gave the necessary details of the relative movements within weeks.

The movement in this case had the characteristics of steady settlement. Excavations found a broken drain at one corner that was weakening the soft clay beneath the foundations.

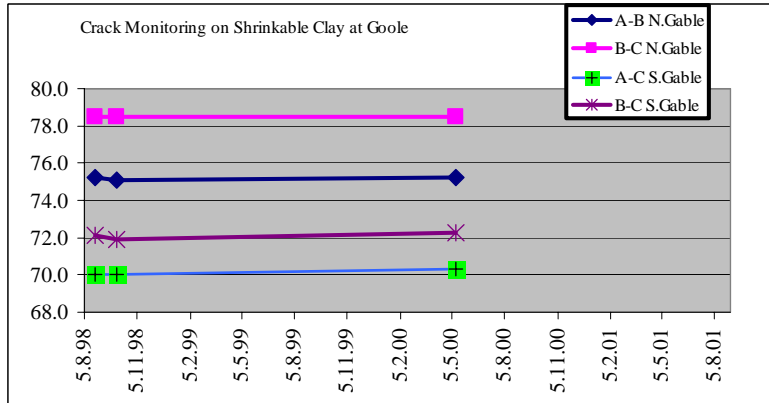
A building approximately 300 years old had obvious signs of major settlement. The householder's bed needed a brick at one end to level it up! Levelling of the bedding courses

indicated that the ends of the building had settled by around 300mm relative to the central door and hallway. Yet there were few major cracks, and in the course of the monitoring, little movement was picked up at one crack and zero at another.

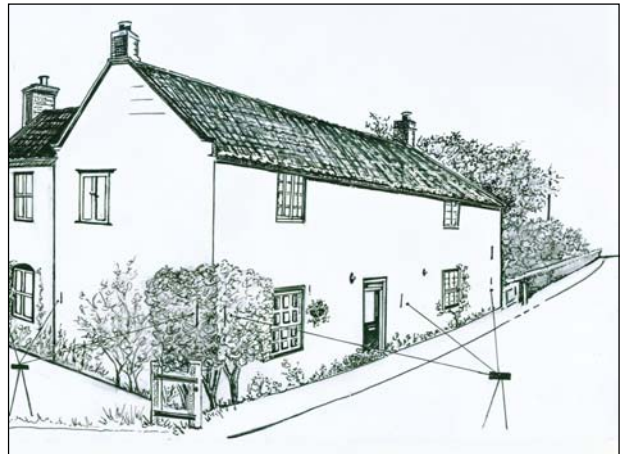
Movement gauges were set up on the south gable wall, and another series were set up along the east front of the house. The two adjacent gauges at the south east side were considered to be a "change point". The actual height difference between the gable and front movement gauges was never measured as it is only the changes in level that are significant. Two gauges at different heights or on different elevations can be considered to be moving together if set on adjacent stones in contact.

The results from Movement Gauges picked up major relative movements within the month of August, some of which was regained over the eleven subsequent months. This still left significant long-term net movement which needed to be prevented.

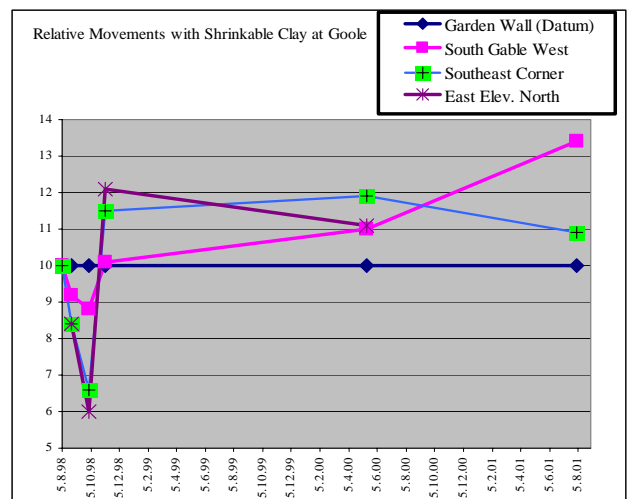
The results from the Movement Gauges indicate that buildings constructed with lime mortar are capable of accommodating large relative movements without undue cracking. It was the small net movement over a calendar year that was causing damage, rather than the much larger seasonal movements.

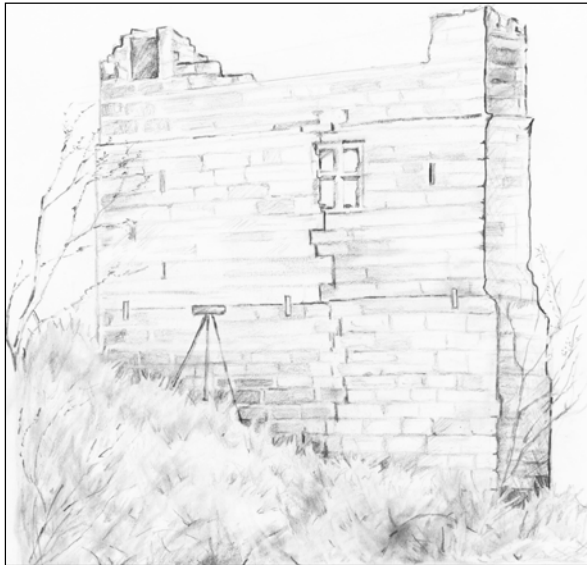
A Medieval Gatehouse to a Norman Motte and Bailey Castle was exhibiting cracking on the north and south elevations. It was initially suspected that the east side of the Gatehouse was sliding into the Moat.

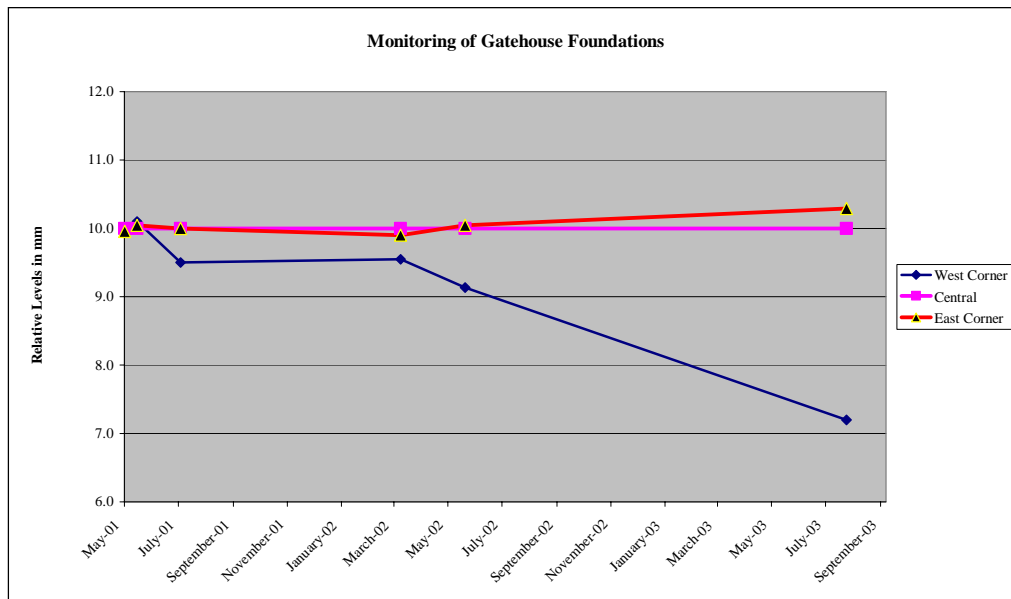
The results quickly indicated that the hypothesis that the gatehouse was falling into the moat was very wrong. It was the corner at the top of the bank that was settling relative to the centre and bottom corner. There was no movement across the crack, and the crack was positioned remote from the actual movement.

After just the second set of readings, the more logical explanation for the movement became apparent. The corner constructed on the Norman Motte piled up by Saxon serfs was settling. The corner constructed in the moat would be on better founding strata.

The position of the cracks gave no indication of where or how the foundations were moving. Cracks appear to relate much more to the wall structure than foundation movements.

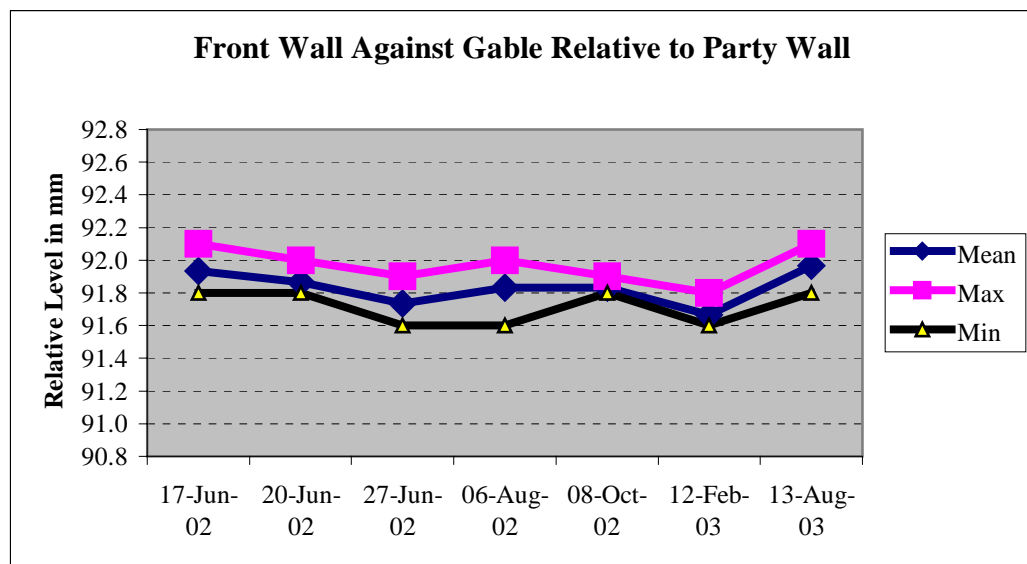
Typical results from one of the eight positions are indicated in the graphs. From the graphs the following was deduced:

1. As the Y-axis for various sets of readings has a scale of only 0.2 mm, the results, even within the first six weeks, were indicating that there were no significant differential movements. The client was informed.
2. Reading errors from inaccuracies in the early versions of the movement gauges and from movement in the automatic level sat on the timber ground floors were of the same order as any actual movement. The extreme and mean readings were therefore plotted.
3. After taking measurements for over a year, the results still indicated no significant differential movement between any of the walls relative to the original party wall.

As cracking was continuing, it was clear that damage must be related high-level distress such as thermal expansion of the superstore. Planned underpinning would not help.
